# Manhole Inspection Summary

Manhole # S15II1006MH

Insp Date: **6/15/07 9:21 AM**

**Location** Address: **2475 COLD SPRING LN**

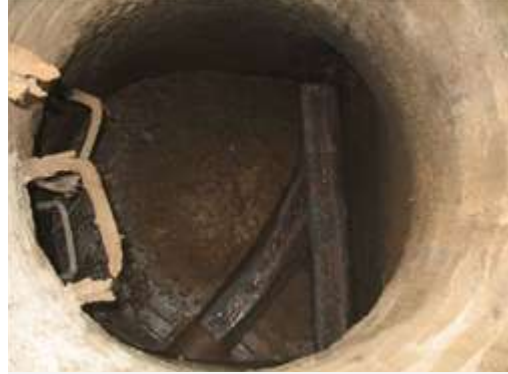
Top View

☒ **Debris** (not Condition related)

☒ **Corroded**

☒ **Evidence Of Surcharge**

Corroded and missing steps. Evidence of surcharge - Bench debris.

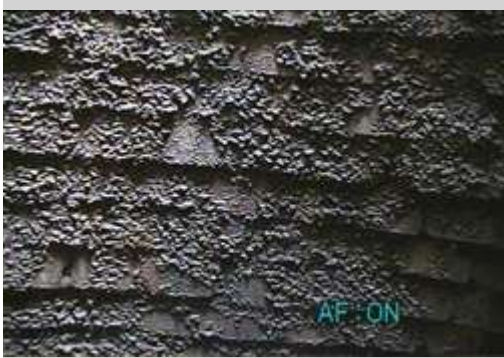
Defect

Infiltration: ☐ None ☐ Joint ☐ Cracks ☐ Mortar ☐ Roots ☒ **Wall**

Corbel and Barrel infiltration.

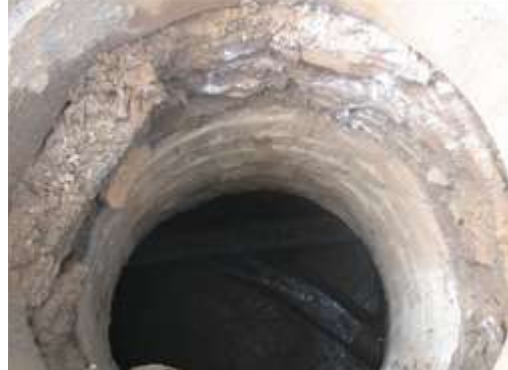
Defect

Offset: **3** (in.)

☒ **Leaks**

Condition: ☐ Sound ☐ Cracked ☐ Root Intrusion ☒ **Loose Brick** ☒ **Deteriorated**

Infiltration: ☐ None ☒ **Joint** ☐ Cracks ☒ **Mortar** ☐ Roots ☐ Wall

Frame leaks. Frame offset. Adjustment deterioration, loose brick and infiltration.

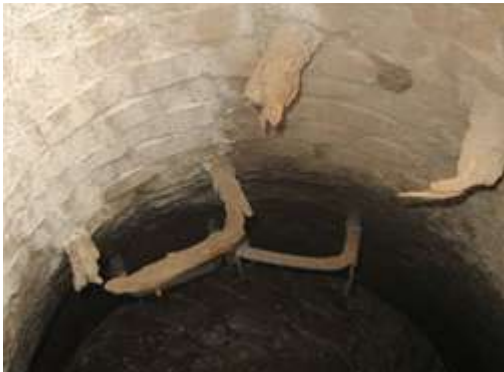
Defect

Corroded and missing steps. Barrel infiltration.

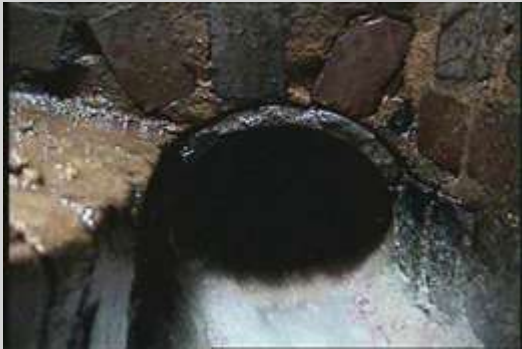
### 8 in. Circular Gravity Sewer Pipe Out @ 12 O'Clock

Infiltration: **Evidence** Pipe Seal Cond: **Unknown**

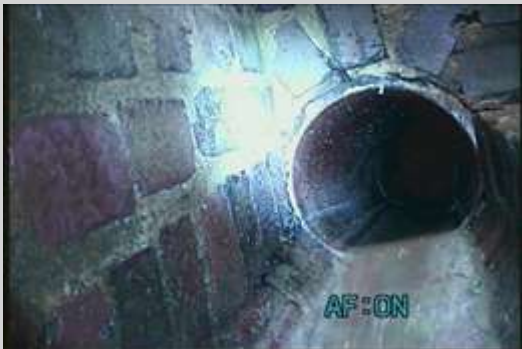
### 8 in. Circular Gravity Sewer Pipe In @ 6 O'Clock

Infiltration: **Evidence** Pipe Seal Cond: **Cracked**
